4510 Arlen

BUILDING AND STANDARDS BOARD AGENDA ITEM # 8 FOR
WEDNESDAY, January 30, 2008
DEVELOPMENT SERVICES
BUILDING PERMITS AND INSPECTIONS

SUBJECT: 4510 Arlen, El Paso, Texas 79924

UNSAFE STRUCTURES REPORT

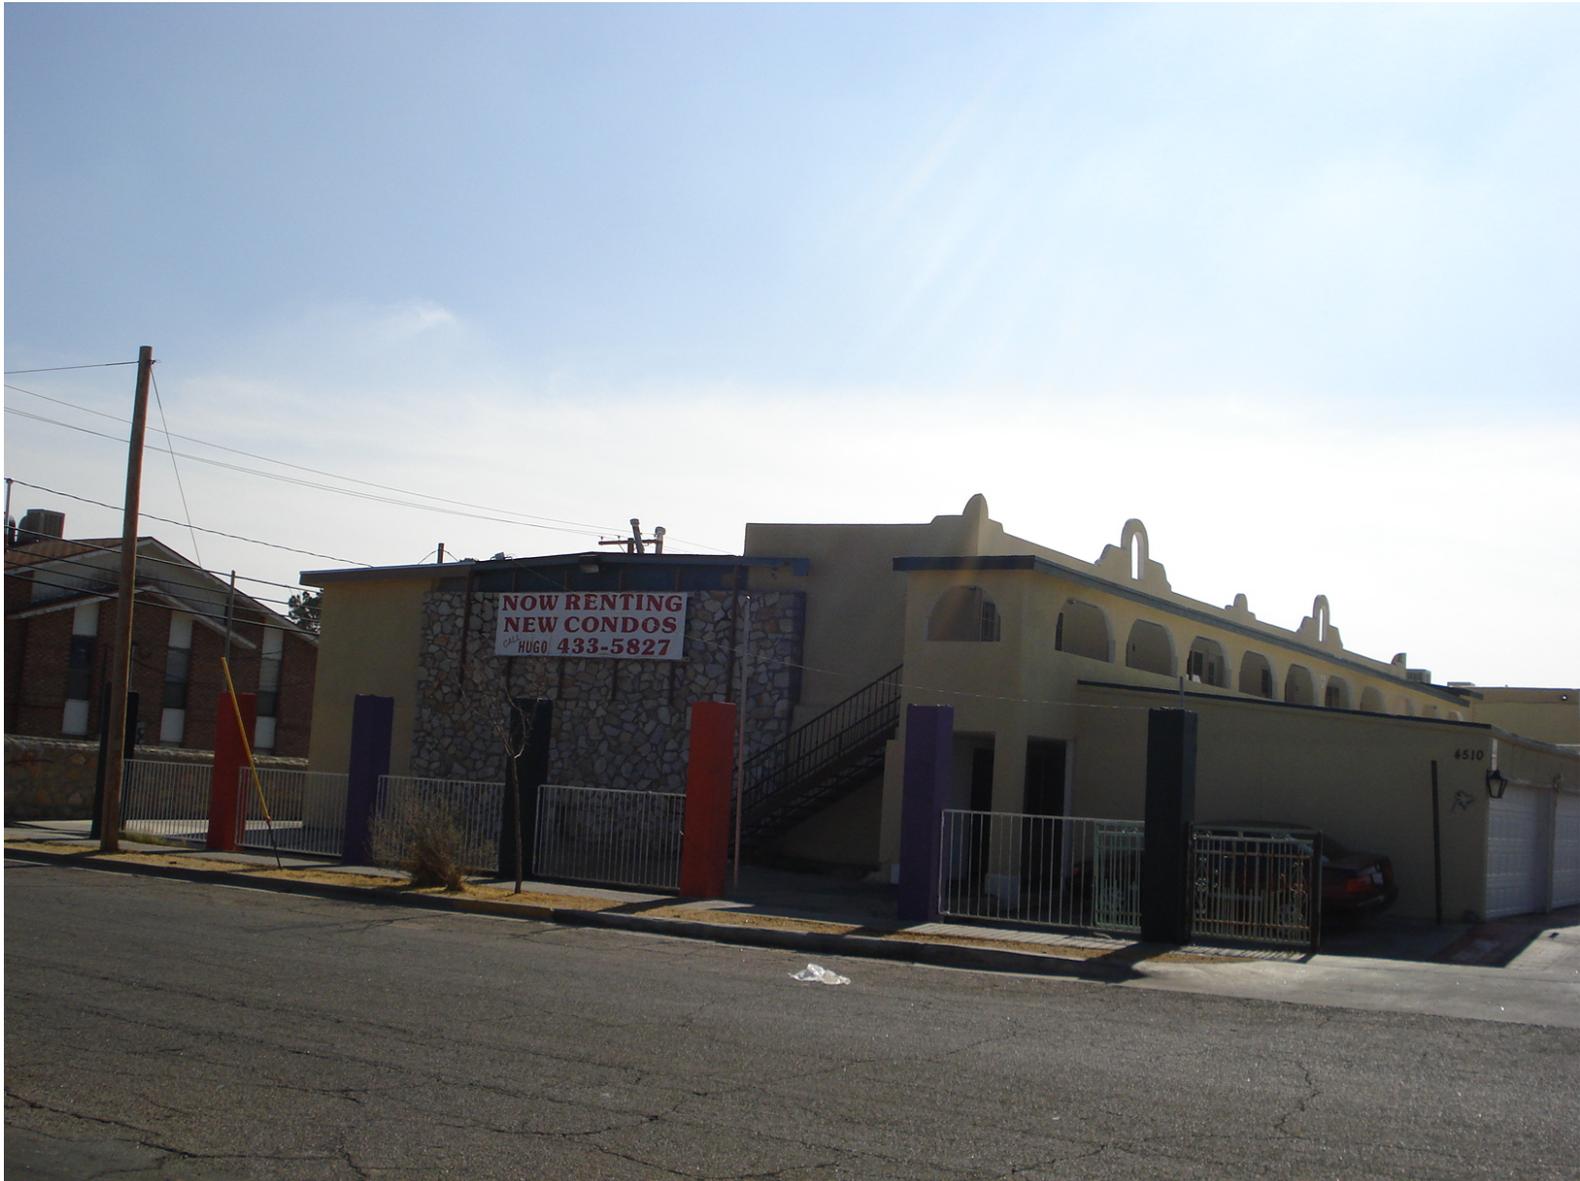
REMARKS: This is a multi-family dwelling unit. The exterior walls are showing signs of deterioration. The structure should be vacated and secured until rehabilitated. The property should be cleaned of all weeds, trash and debris.
