# 5104 ALPS

BUILDING AND STANDARDS BOARD AGENDA ITEM # 8 FOR  
WEDNESDAY, FEBRUARY 23, 2011

SUBJECT: 5104 Alps, El Paso, Texas, 79904

# UNSAFE STRUCTURES REPORT

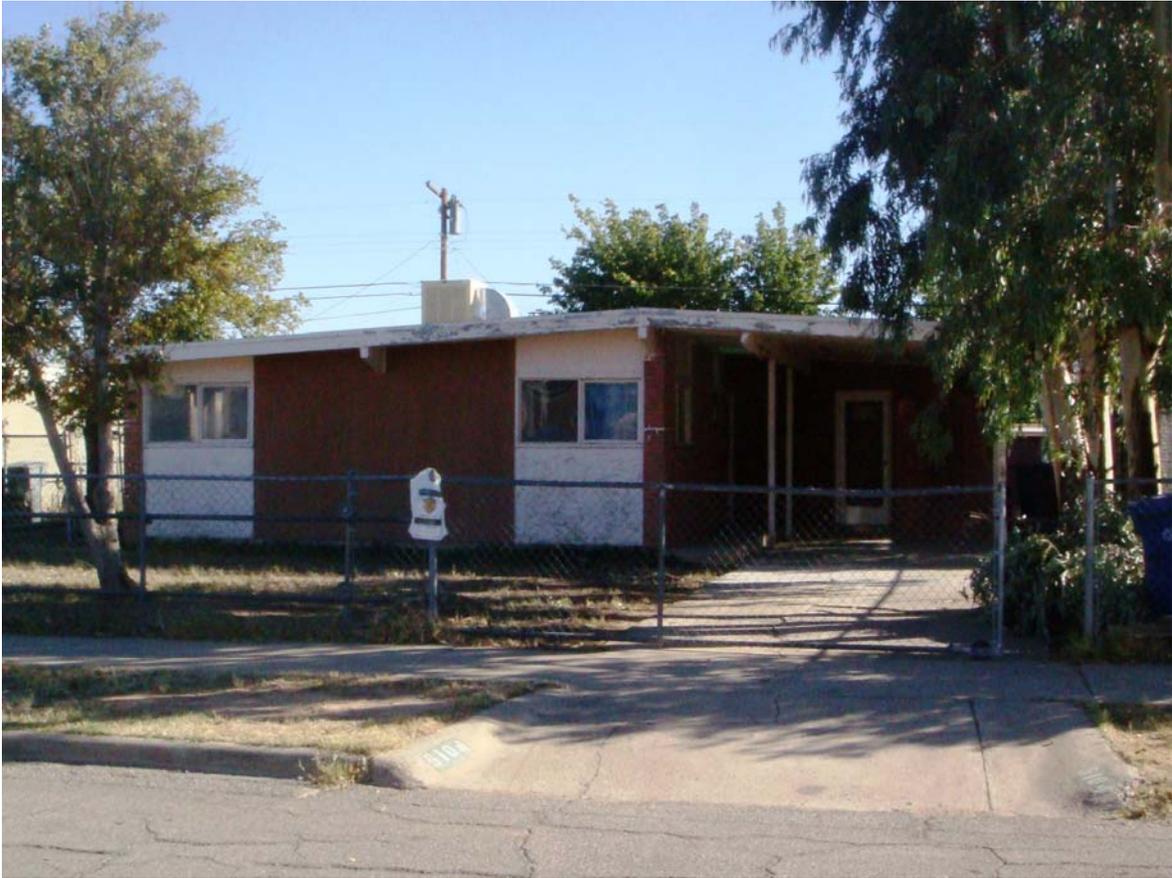
- 1) First investigated on November 12, 2010. The single family dwelling was built in 1955, according to Central Appraisal records, constructed of Brick veneer and siding and a wood framed roof structure. The structure was found open and abandoned and in an advanced state of disrepair. The exterior of the structure is showing signs of rapid deterioration due to lack of maintenance and exposure to the elements. There are several structural cracks on the brick veneer. The siding, fascia, flashing and roof system are decaying and deteriorated due to lack of maintenance. There is trash, weeds and debris throughout the property.
