908 CHIHUAHUA

BUILDING AND STANDARDS BOARD AGENDA ITEM # 9 FOR
WEDNESDAY, MAY 25, 2011

SUBJECT: 908 S. Chihuahua Street, El Paso, Texas 79901

UNSAFE STRUCTURES REPORT

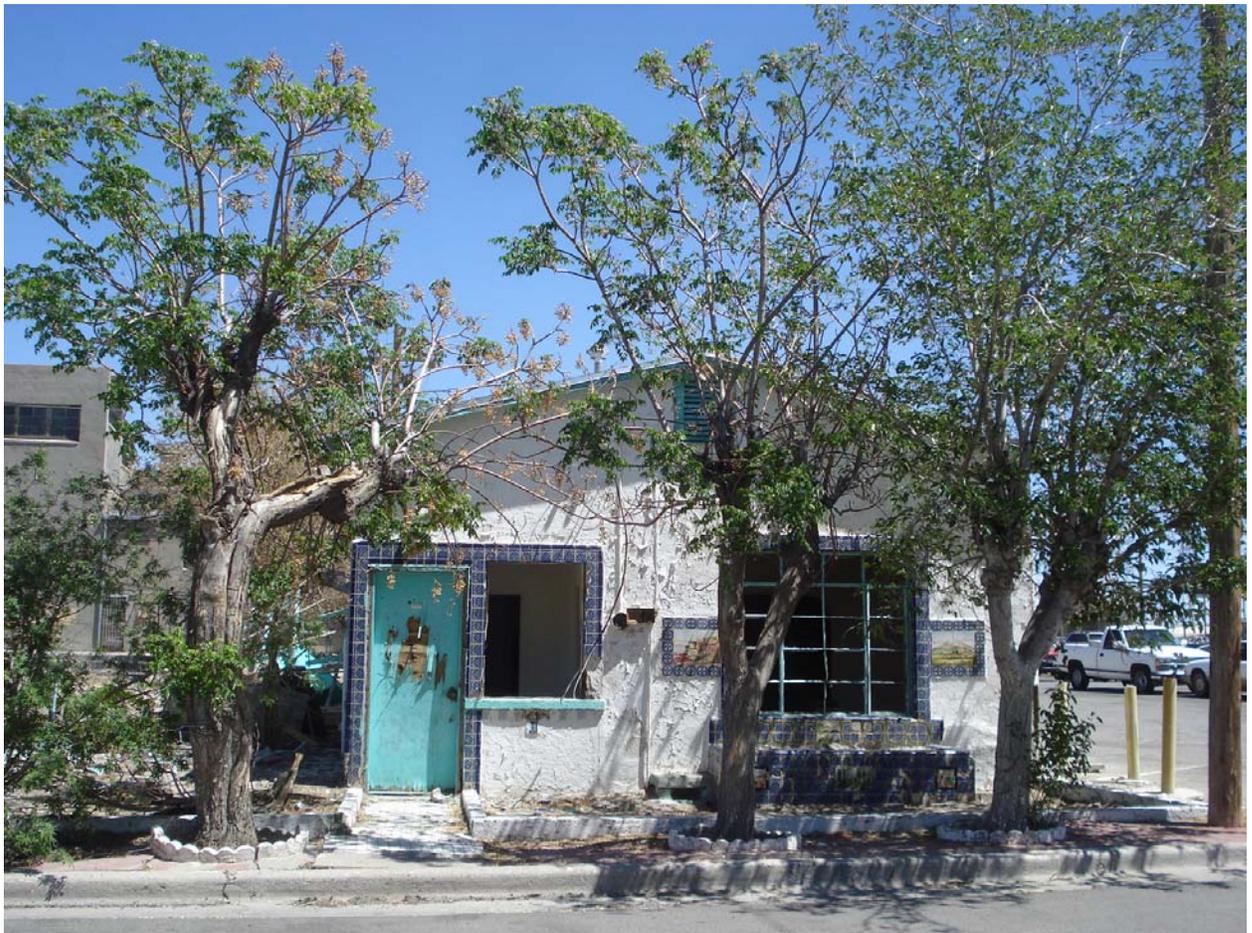
- 1) First investigated April 8, 2011. According to Central Appraisal records the structures were built in 1950 and are located in the Chihuahuita Historical District. Upon investigation they were found open and abandoned and being used as harborage by vagrants. The doors, windows and walls are broken due to lack of maintenance and vandalism. The roof and ceiling assembly is warped on the main structure. There is graffiti and drug paraphernalia throughout. The property is full of trash, weeds and debris.
- 2) A certified condemnation letter was mailed to Jesus Roberto Arreola, 2058 S. Amigo Avenue, Tucson, AZ 85713-3908.
- 3) Certified notices of the public hearing scheduled for May 25, 2011, were mailed to the owners and all interested parties on May 12, 2011.
- 4) As of May 10, 2011, \$2,032.31 in taxes is owed.

REMARKS: This single family dwelling was built in 1950. The structure was found in a state of disrepair, open, abandoned and being used as harborage by vagrants. This department recommends that the structures be demolished within thirty (30) days. The property be cleaned of all weeds, trash and debris within thirty (30) days.
