# 1908 MAGOFFIN

BUILDING AND STANDARDS BOARD AGENDA ITEM # 10 FOR  
WEDNESDAY, JULY 30, 2008

SUBJECT: 1908 Magoffin Avenue, El Paso, Texas 79901

# UNSAFE STRUCTURES REPORT

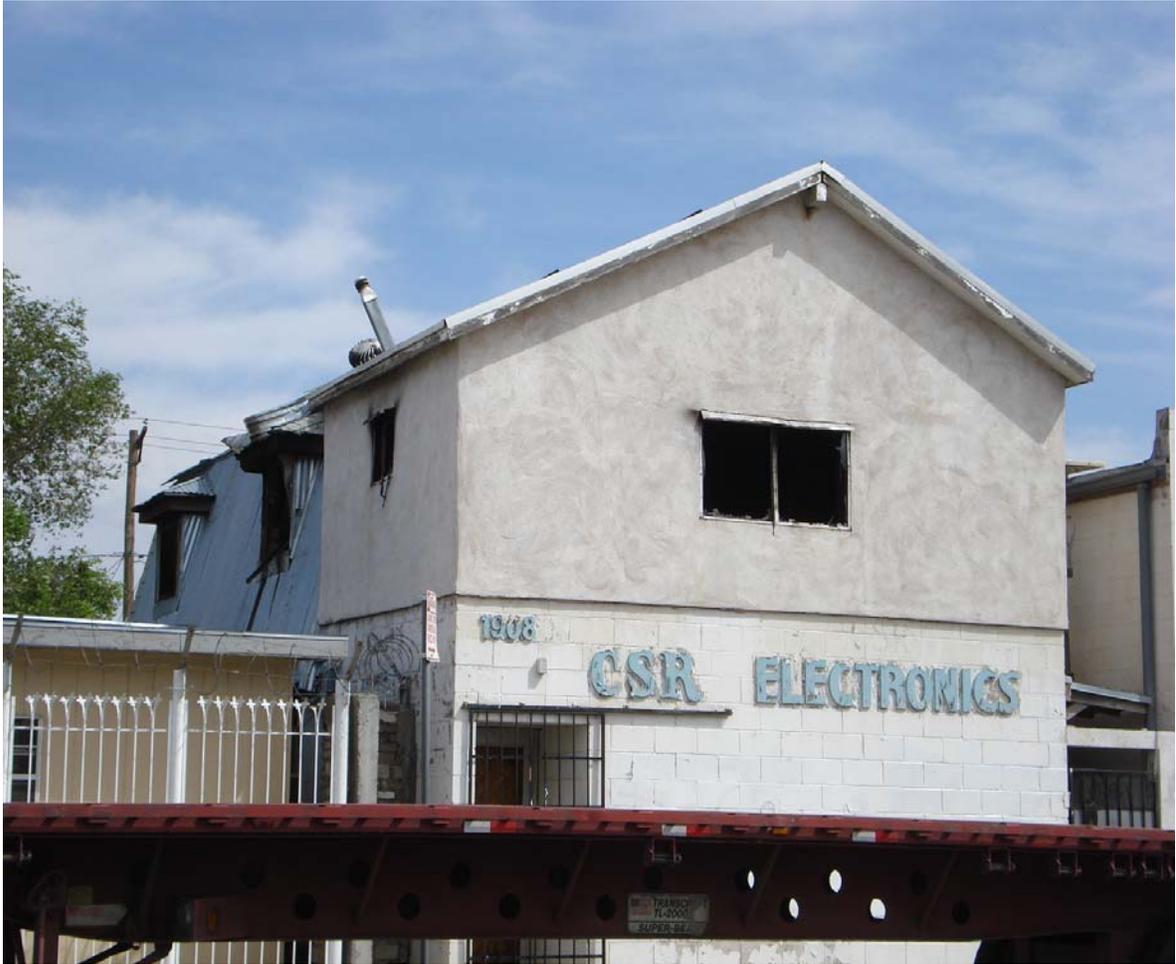
- 1) First investigated April 18, 2008. The abandoned commercial buildings were built in 1912 and altered in 1950. The two story building sustained fire damage on May 17, 2008 compromising the structure and making it unsound. The roof and ceiling assembly have inadequate support, there are exposed and missing studs, cracks and dry rot on the walls. The buildings were found to be open and abandoned, full of graffiti, vandalized and being used as harborage by unwanted persons.
- 2) A certified condemnation letter was mailed to Irma Leticia Caudillo & 2, 2524 Rudder Place, El Paso, Texas 79936.
- 3) Certified notices of the public hearing scheduled for July 30, 2008, were mailed to the owners and all interested parties on July 15, 2008.
- 4) As of July 08, 2008, \$3,210.61 in taxes is owed.

**REMARKS:** This is an abandoned two story commercial building that sustained fire damage on May 17, 2008. The structure was built in 1912, is in an advanced state of disrepair, vandalized and being used as harborage by unwanted persons. The structure should be demolished and the property cleaned of all weeds, trash and debris.

- 1) That the structures be condemned as substandard, and unfit for habitation or use and a hazard to the public health, safety, and welfare; and
- 2) That the structures are not in substantial compliance with the municipal ordinances regulating fire protection, structural integrity, and disposal of refuse; and
- 3) That the structures' certificate of occupancy be revoked; and
- 4) That the structures cannot be repaired; and
- 5) That the structure be demolished and the premises be cleaned and maintained clean of all weeds, trash, and debris within 30 days; and
