2219 BASSETT

**BUILDING AND STANDARDS BOARD AGENDA ITEM #4 FOR
WEDNESDAY, AUGUST 29, 2012**

SUBJECT: 2219 Bassett Avenue, El Paso, Texas, 79901

UNSAFE STRUCTURES REPORT

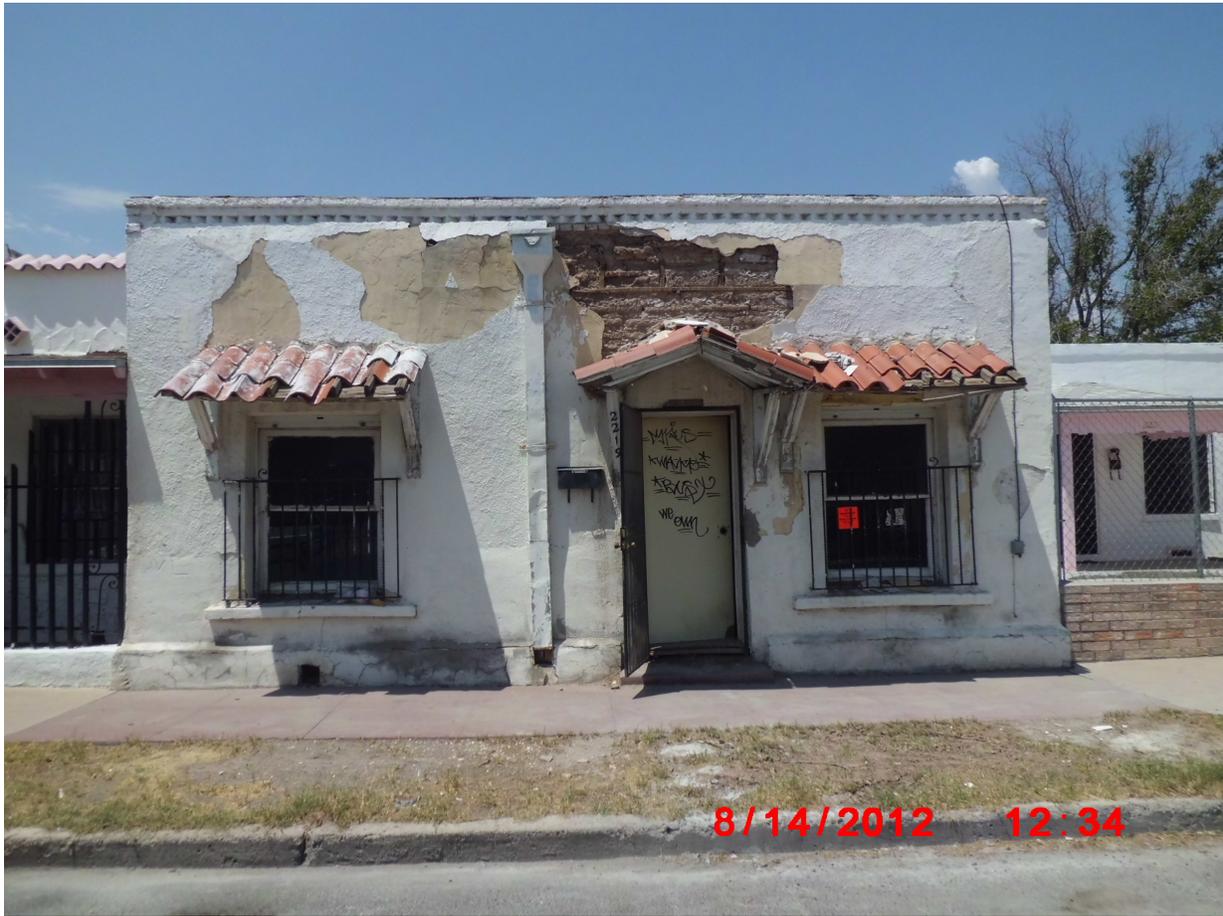
- 1) First investigated on August 4, 2010. The multifamily dwellings were built in 1949, according to Central Appraisal records, constructed of Adobe walls with plaster coating and a wood framed roof structure. The structures were found open, abandoned, in an advanced state of disrepair and being used as harborage by vagrants. The exterior of the structures is showing signs of rapid deterioration due to lack of maintenance and exposure to the elements. The plaster coating has fallen in several areas and onto the sidewalk posing a safety hazard to pedestrians and exposing the underlying adobe to the elements. There are several structural cracks throughout the structures. The roof and ceiling assembly has collapsed in the rear structure; and is failing in the main structure allowing natural light to seep through. The plumbing, electrical and mechanical systems are none existent. The property is full of weeds, trash and debris.
