701-719 Nino Aguilera St.

BUILDING AND STANDARDS BOARD AGENDA ITEM #8 FOR
WEDNESDAY, SEPTEMBER 26, 2007

SUBJECT: 701-719 Nino Aguilera Street AKA 701 Tornillo Street

UNSAFE STRUCTURES REPORT

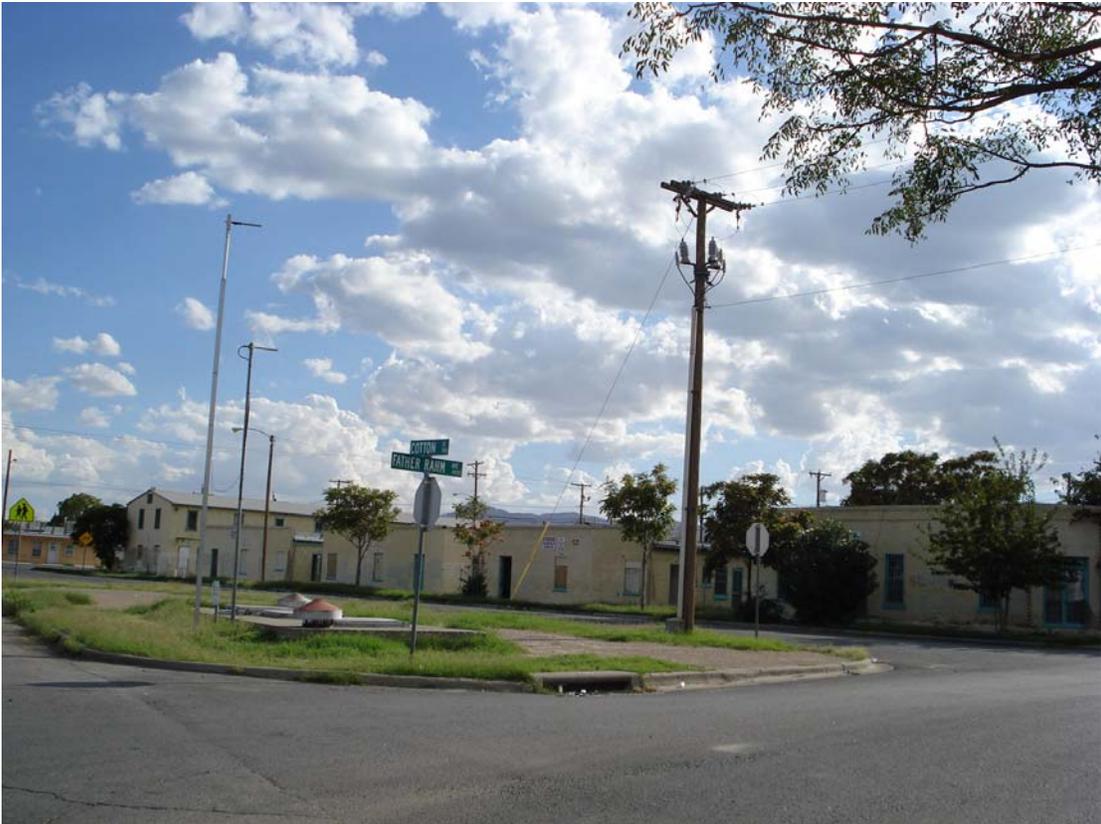
REMARKS: This is an open and abandoned multifamily dwelling. The interior walls are showing signs of advanced deterioration. The structure should be secured and the property cleaned of all weeds, trash and debris.
