# 815 S TAYS

**BUILDING AND STANDARDS BOARD AGENDA ITEM #6 FOR  
WEDNESDAY, OCTOBER 3, 2012**

**SUBJECT:** 815 Tays Street, El Paso, Texas, 79901

# UNSAFE STRUCTURES REPORT

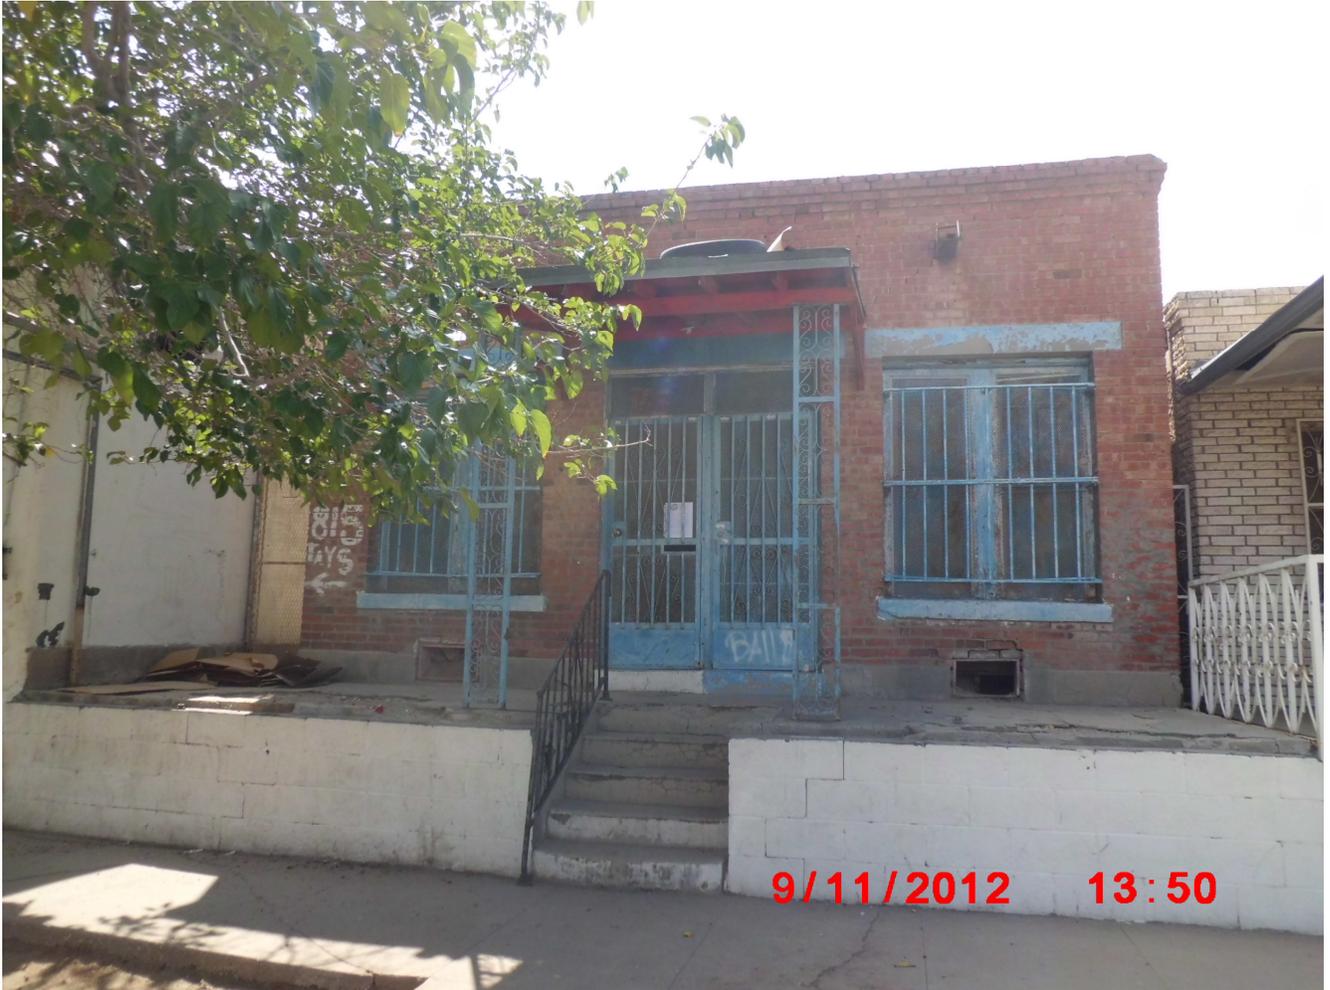
- 1) First investigated on May 30, 2012 due to a referral from EPPD. The single family dwelling was built in 1924, according to Central Appraisal records, constructed of Adobe walls with brick veneer in the front and plaster coating throughout the rest of the structure and a wood framed roof structure. The structure was found open, abandoned, in an advanced state of disrepair and being used as harborage by vagrants. The structural integrity has been compromised due to lack of maintenance and exposure to the elements. The plaster coating has fallen in several areas exposing the underlying adobe to the elements. The roof and ceiling assembly is failing and allowing natural light to seep through. There are holes, cracks and graffiti throughout the walls. There is drug paraphernalia throughout the interior of the structure. The plumbing, electrical and mechanical systems are none existent. The property is full of weeds, trash and debris.

**REMARKS:** This single family dwelling built in 1924 was found open, abandoned and being used as harborage by vagrants as a drug gallery and is in a state of disrepair. The department recommends that the structure be demolished within thirty (30) days; and that the property be cleaned of all weeds, trash and debris within thirty (30) days and maintained clean of all weeds, trash and debris..
