3915 TULAROSA

BUILDING AND STANDARDS BOARD AGENDA ITEM # 8 FOR
WEDNESDAY, NOVEMBER 17, 2010

SUBJECT: 3915 Tularosa Avenue, El Paso, Texas, 79903

UNSAFE STRUCTURES REPORT

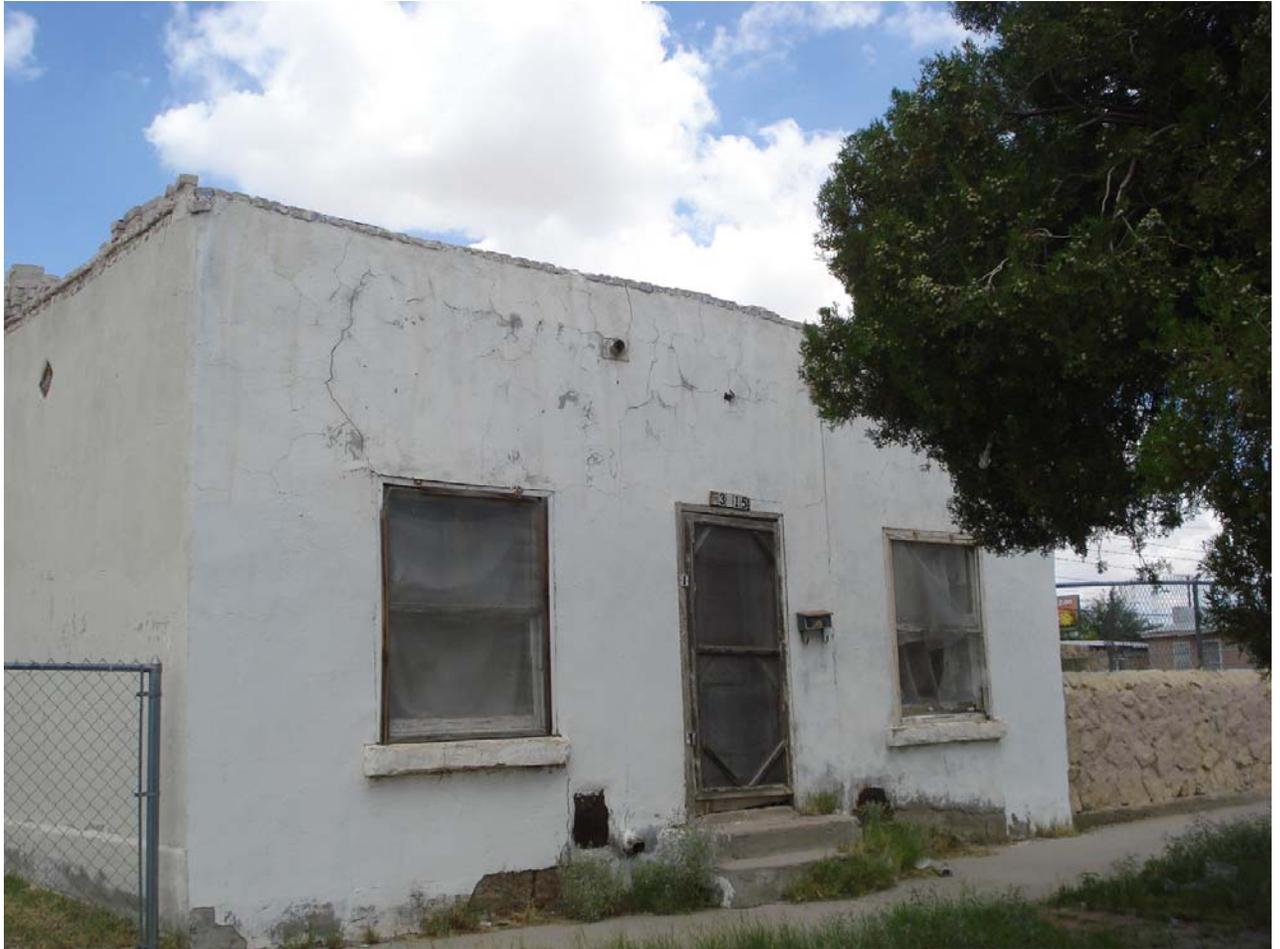
- 1) First investigated on April 28, 2010. The single family dwelling was built in 1920, according to Central Appraisal records, of Adobe walls covered with plaster coating and wood framed roof structure. The structure was found abandoned and in an advanced state of disrepair. It appears to be used as a commercial storage area. The exterior of the structure is showing signs of rapid deterioration due to lack of maintenance and exposure to the elements. The plaster coating has fallen in several areas exposing the underlying adobe to the elements. There are several structural cracks on the exterior walls that are ready to collapse. The roof and ceiling assembly and roof coverings have not been maintained allowing the natural light to seep through. There is exposed wood framing that is decaying due to exposure to the elements.
