Microbial Investigation

Lincoln Center
4001 Durazno
El Paso, Texas

City of El Paso
Attn.: Mr. John Garza
7969 San Paulo
El Paso, Texas 79907

**Sun
City
Analytical
Inc.**

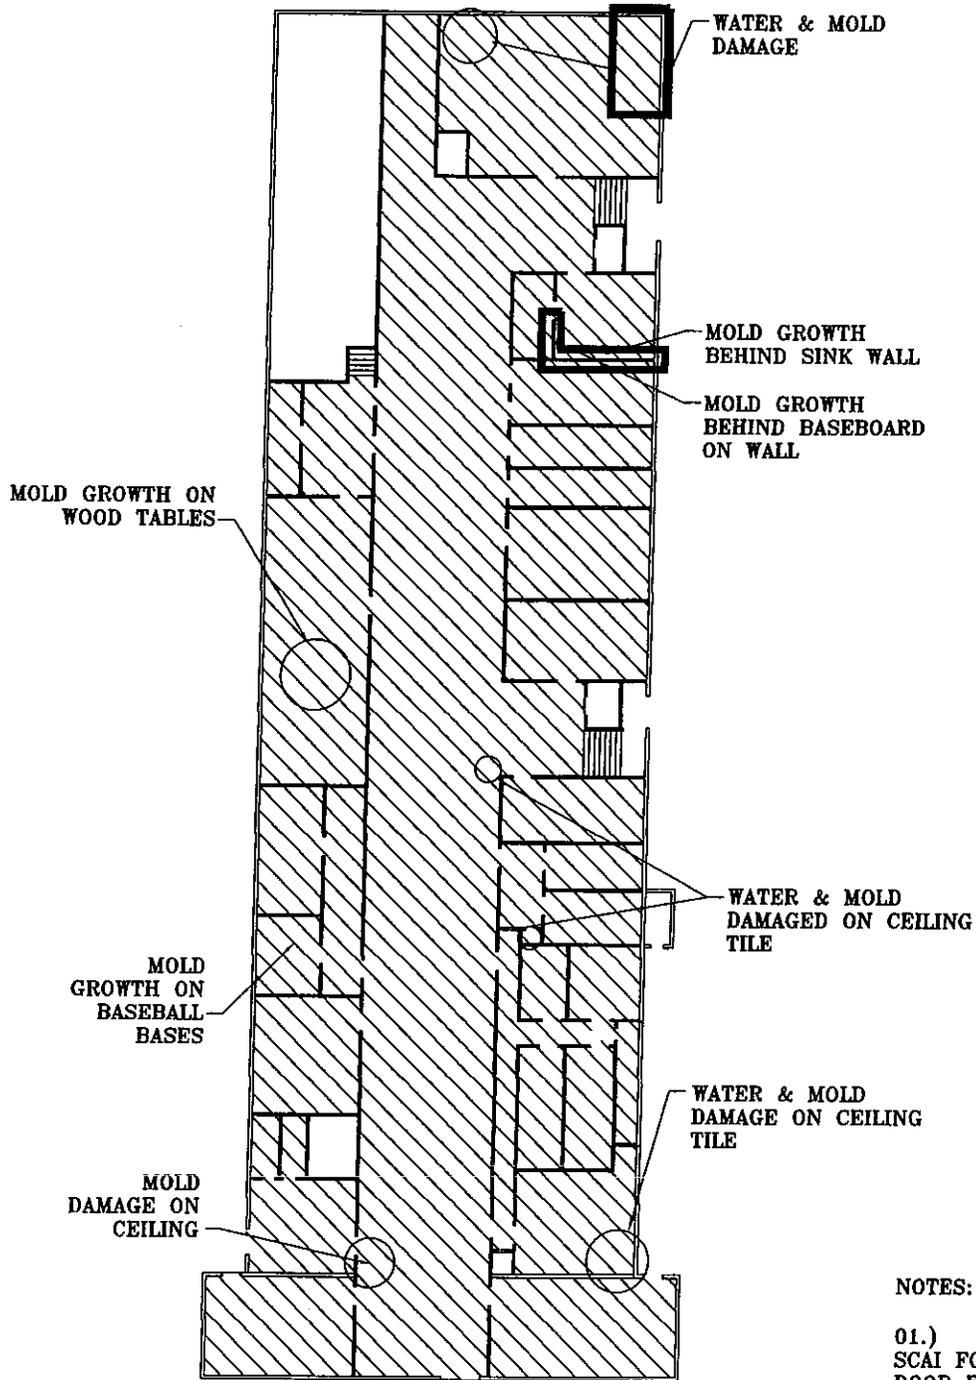
MICROBIAL LOCATION

01.)
SCAI FOUND SOME
DOOR FRAMES AND
DOORS WITH MOLD
GROWTH

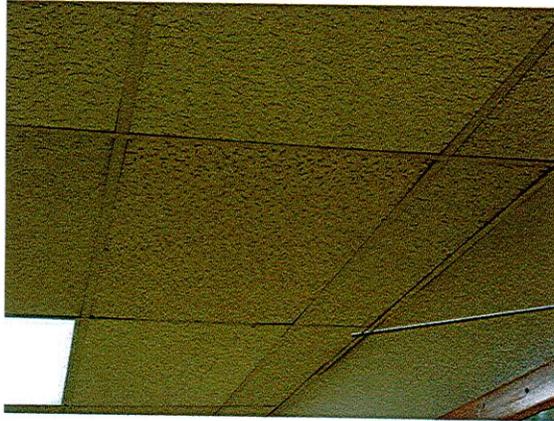
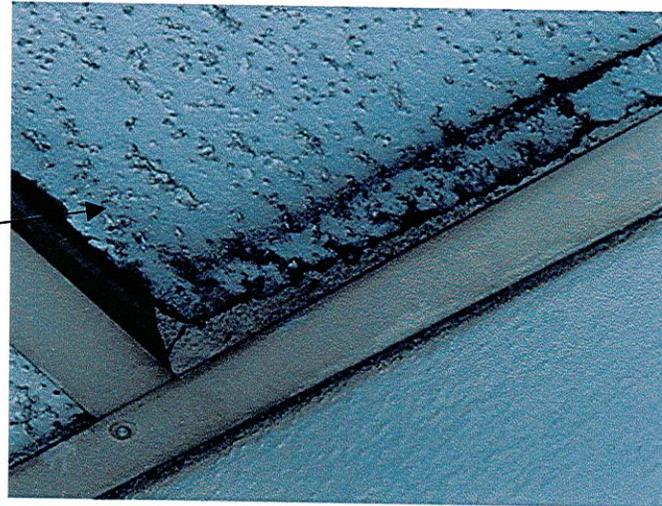
SCAI found the hallways have 2x4 acoustical ceiling tiles that appear to have some microbial growth in the corners. Moreover, the ceiling tiles appear to be curving up. This is an indication that the building has strong positive pressure. Upon investigation SCAI found that all the offices have only supply vents and no returns. All the rooms are positive to the hallway, but the hallway has no return or relief duct. The supply air is pushing the ceiling tile up and forcing air up the corners. This cooling in the building is done by evaporative cooling, therefore, the water sits on the tiles and accumulates and thus the microbial growth. SCAI also found the light fixtures above the ceiling tiles are rusted as are the hanging wires for the drop ceiling. This indicates excess moisture is remaining in the air plume or this building had some heavy rain damage at some point.

Ceiling Tiles with Microbial Growth

Both the 1st floor and Basement have this condition.
See drawing in this report for exact location of tiles.

- SCAI recommends that the heating units be replaced or thoroughly checked and cleaned of all rust material.
- SCAI recommends that all the ceiling tiles identified with microbial growth be removed by a TDSHS remediation contractor overseen by a mold assessment consultant, such as SCAI. The remediation of the tiles is governed by the TDSHS mold remediation regulations and the City of El Paso must perform all mold remediation work in this building by following these regulations.

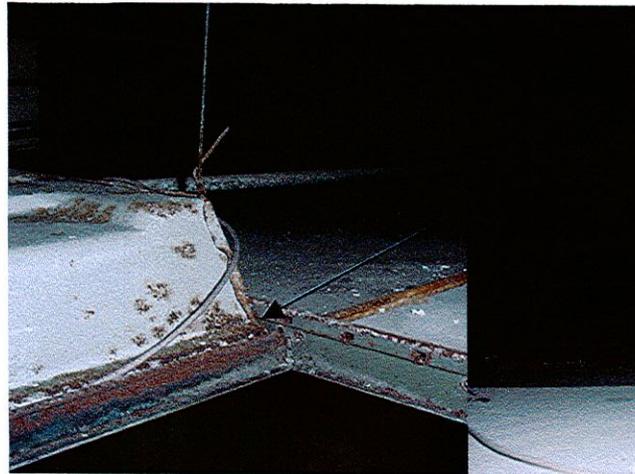
Problems Above Ceiling Tiles

Rust can be seen on light fixtures, ceiling tile grid, hangers, and any metal above in air plume

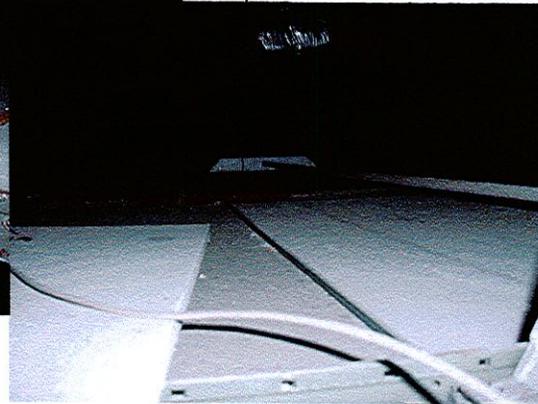
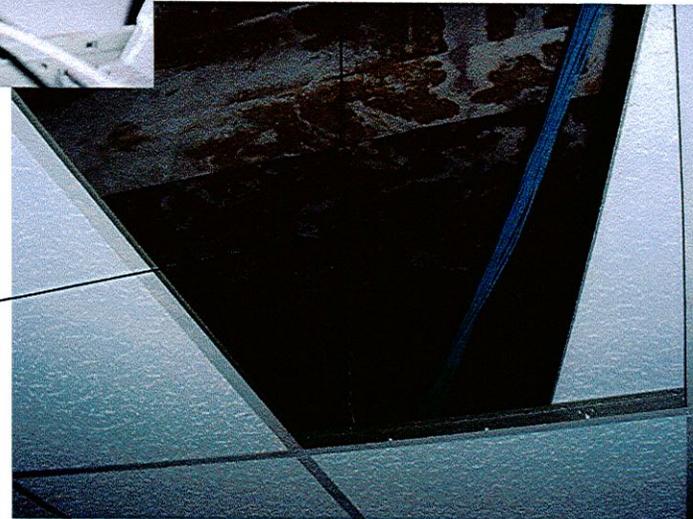
1st Floor

Concrete deck above ceiling tiles
Indicates previous water damage.

- SCAI recommends that the concrete decks above the ceiling tiles on the 1st floor be decontaminated and treated. This work should be done by a TDSHS remediation contractor overseen by a mold assessment consultant, such as SCAI.

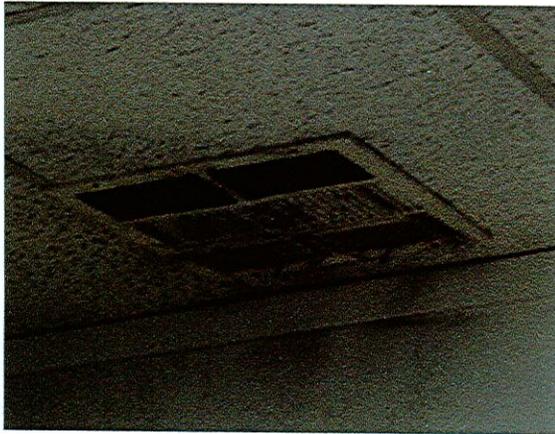
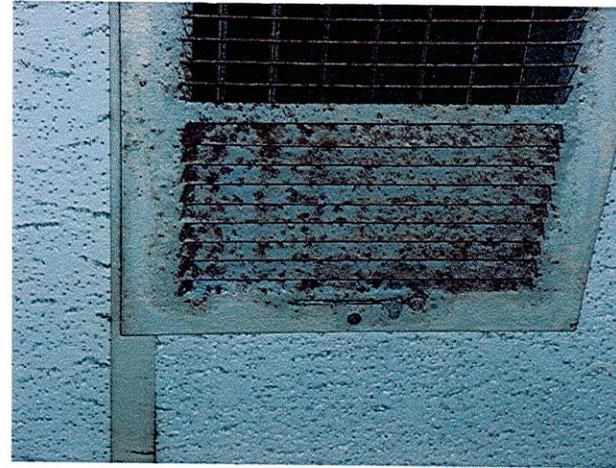
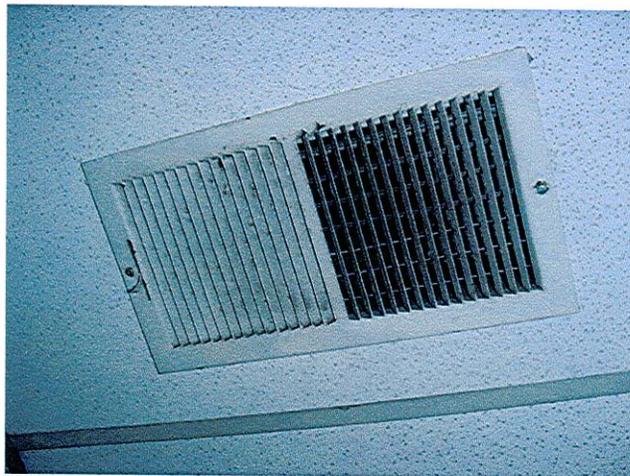
The duct system and registers were found to contain rust and soot. SCAI recommends the duct system be cleaned and sanitized. SCAI only located supply registers and never found return air or relief exhaust vents. All rooms are positive pressure and pushing all air into the hallways which do not have any supply or return exhaust.

Supply Grills with Microbial Growth or Soot

This condition was found throughout the building.

- The duct system in the building should be cleaned and disinfected by a TDSHS remediation contractor overseen by a mold assessment consultant, such as SCAI.

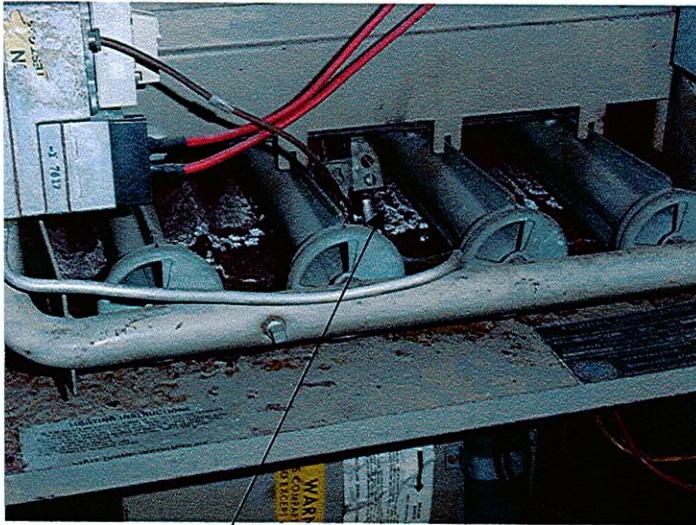
The heating to the building is provided by gas fired units located inside the building. SCAI inspected all the units in the first floor and basement. SCAI found that the units, especially around the burners, had extensive rust. The units looked like that had experience a flood or big water intrusion. One unit on the first floor, north side of the hallway, SCAI found the return vents were covered with shelves and materials. Moreover, the return air ducts were inside a closet that was kept closed. This unit is in need of modification to allow the unit to operate properly.

Heater Units

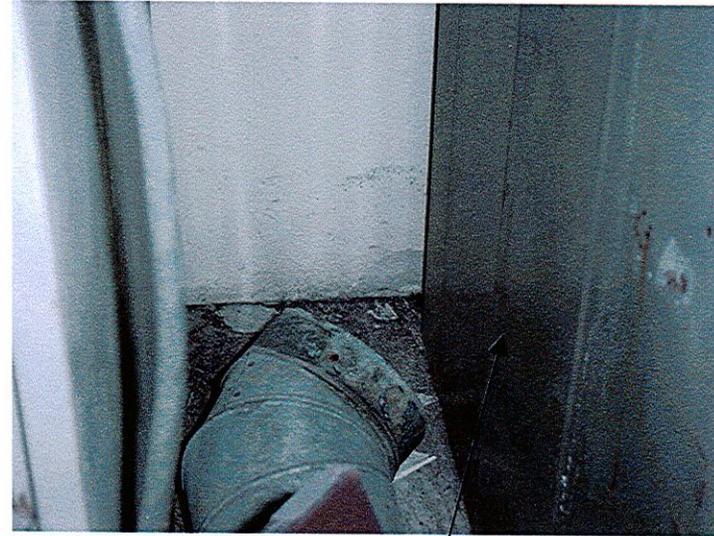
Rust in Heater Unit

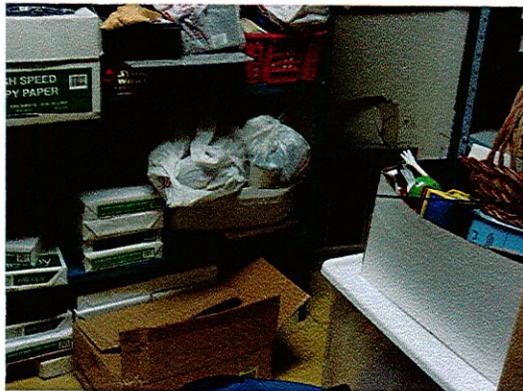
Microbial growth in heater closet

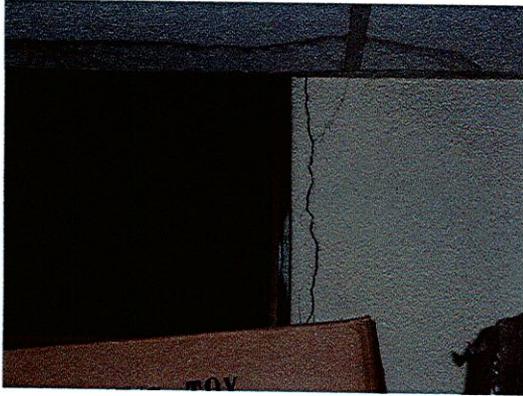
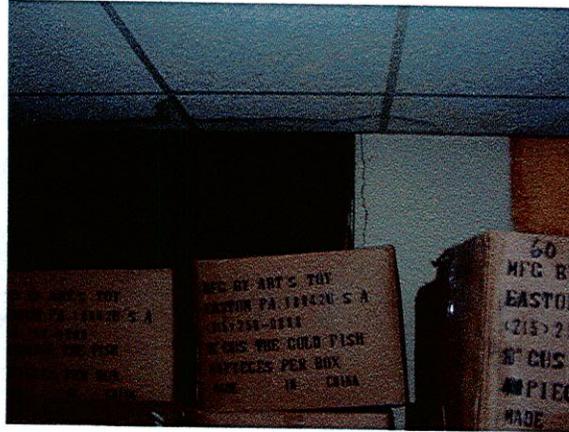
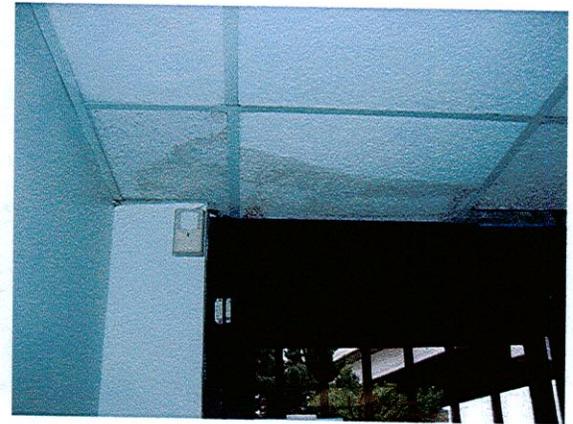
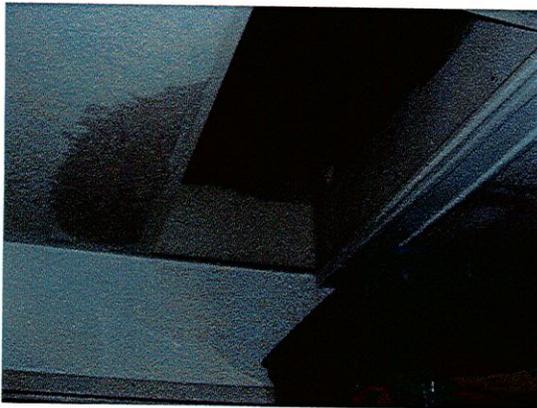
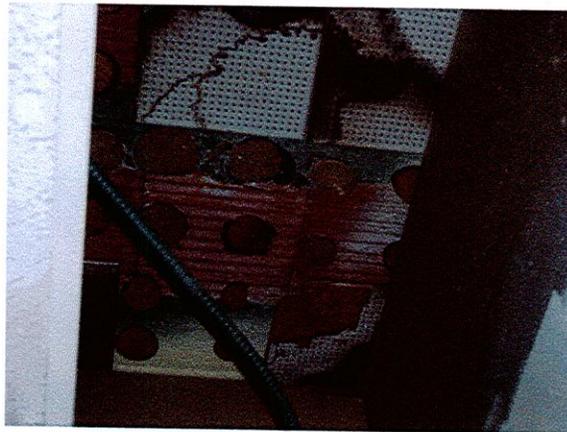
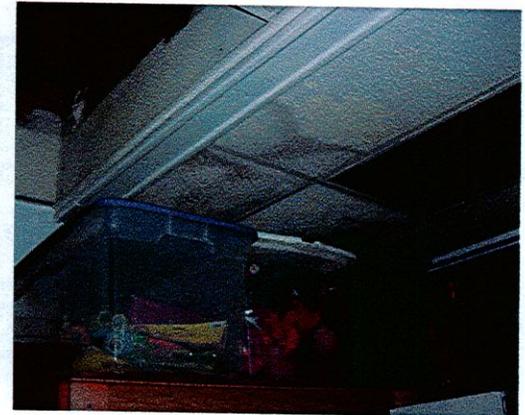
Heater return air vents covered.
Special promotions storage area.

Ceiling Tile Water and Mold Damage

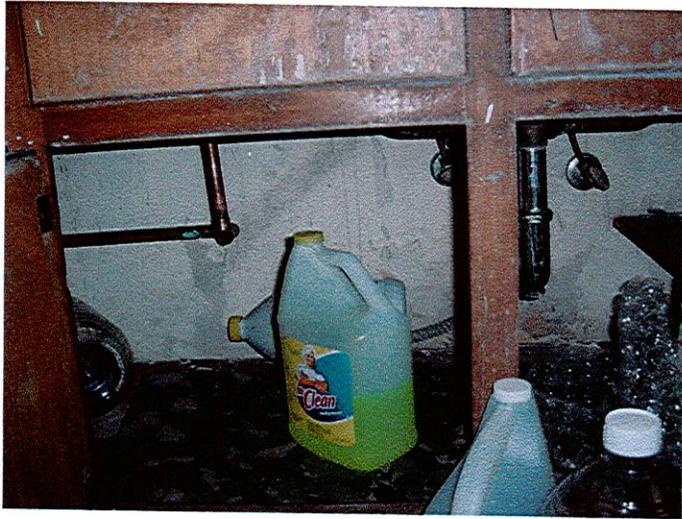
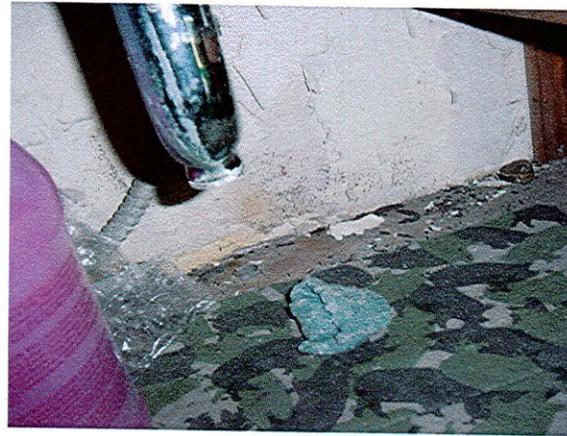
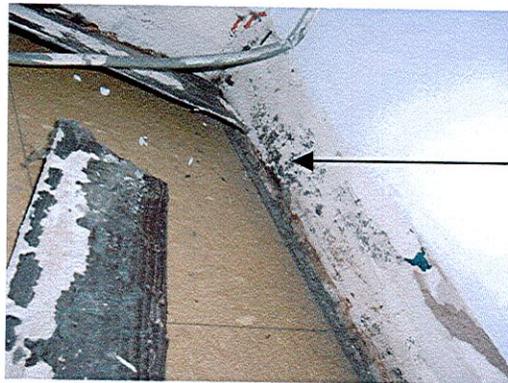
Sink in Janitors Closet with Mold Growth

- SCAI recommends that all areas with mold growth be decontaminated and/or removed by a TDSHS remediation contractor overseen by a mold assessment consultant, such as SCAI. All walls, floors, ceilings, and surfaces need to be decontaminated.

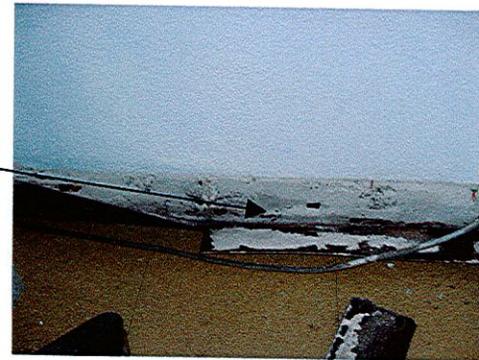
Baseboard next to Sink has mold growth

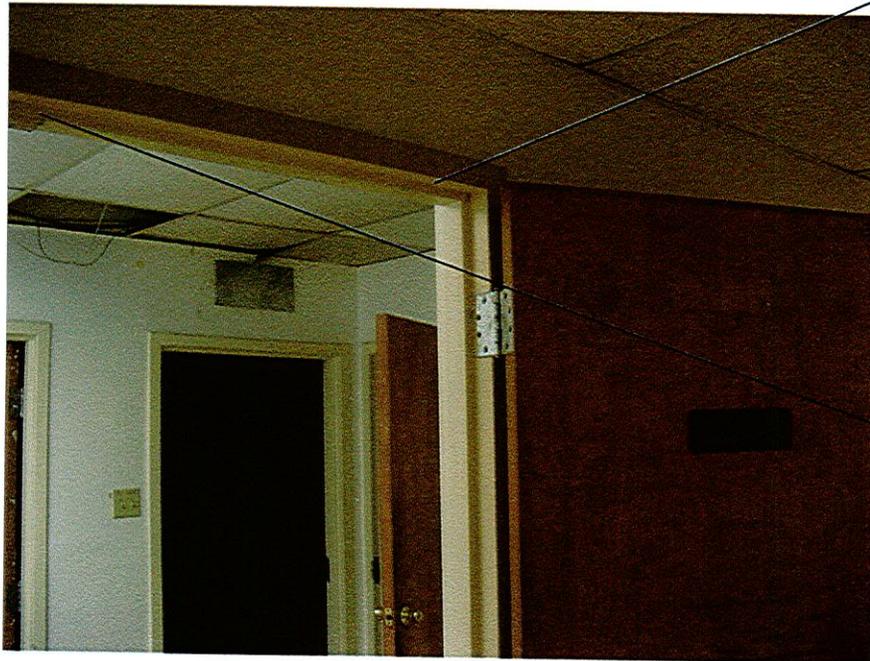
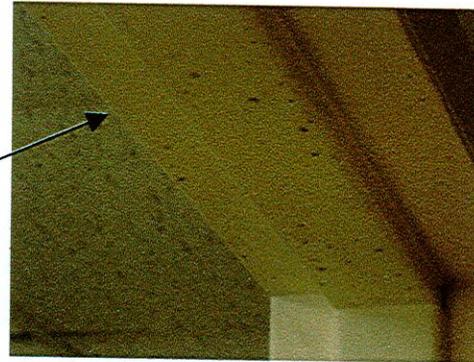
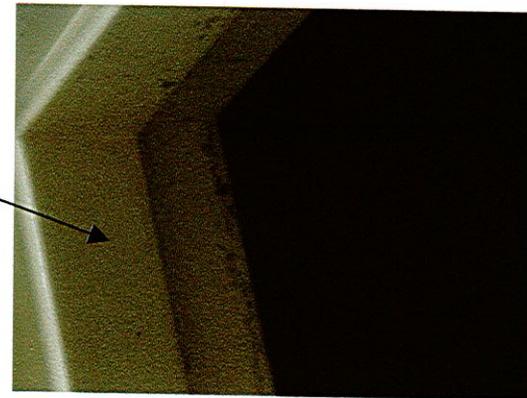
Mold Growth on Doors and Frames in Basement Area

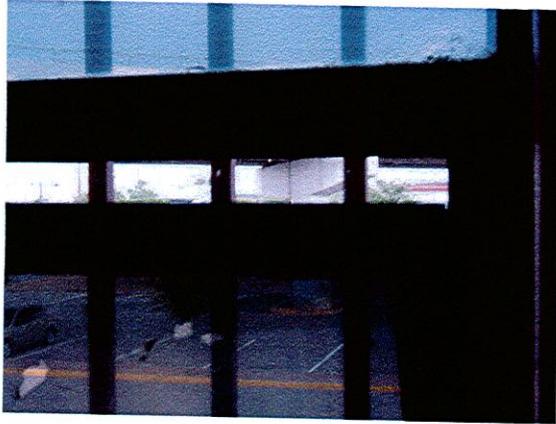
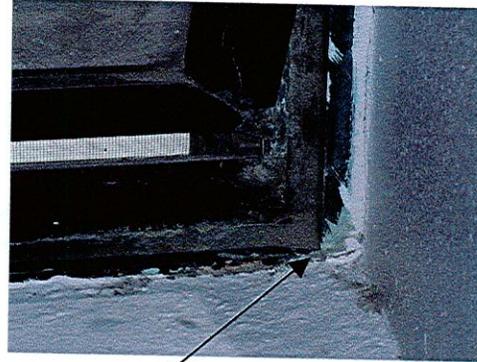
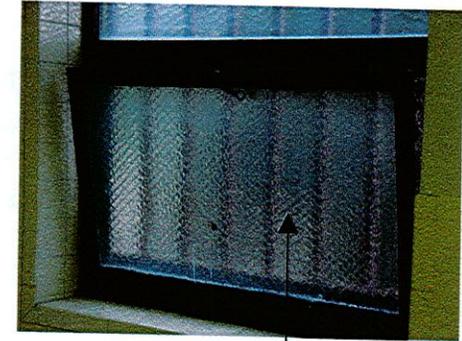
Sources of Water Intrusion

Window caulking missing or damaged

- The exterior cracks on the plaster walls need to be repaired.
- The windows need to be re-caulked. Some windows need to be either repaired or replaced.

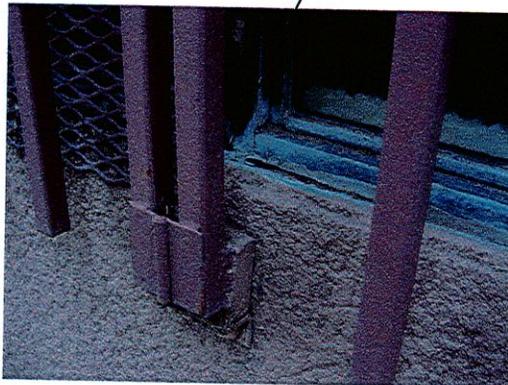
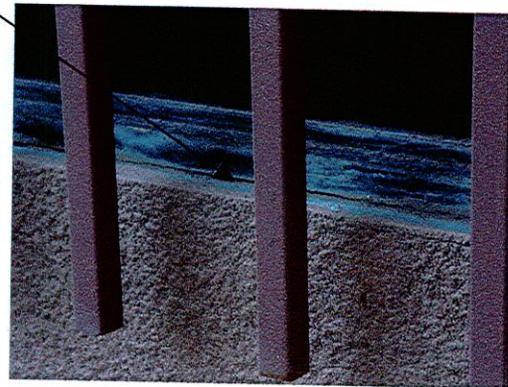
Window in 1st
Floor bathroom
dose not close
properly.

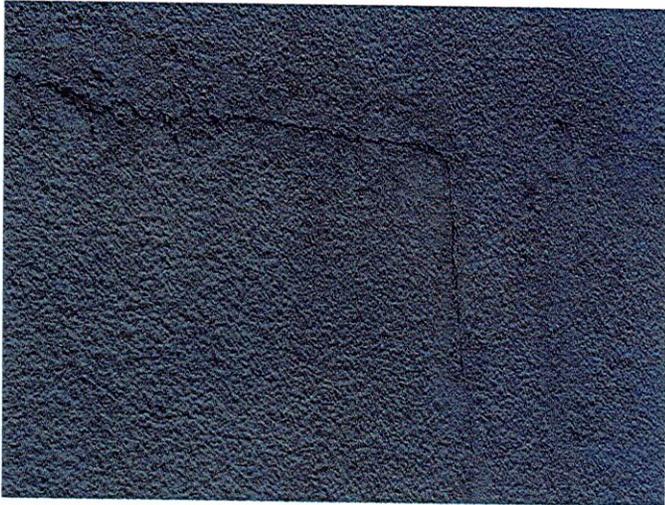
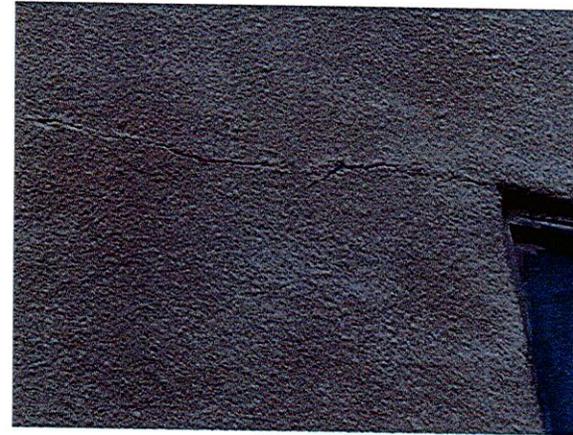
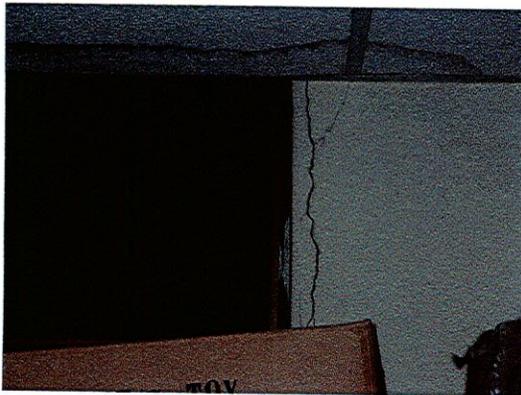
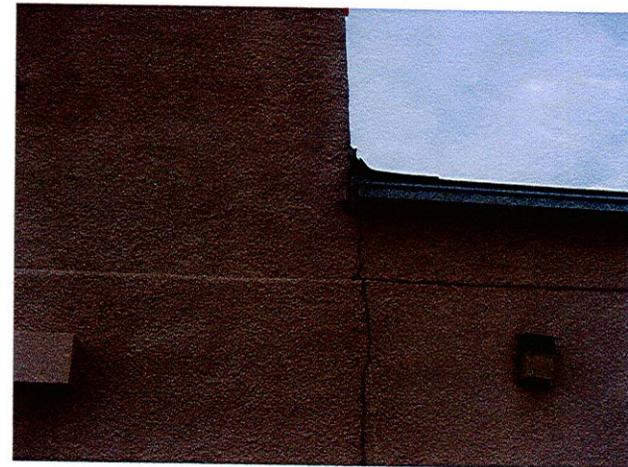
Cracks on Exterior Plaster Could be Source of Water Intrusion

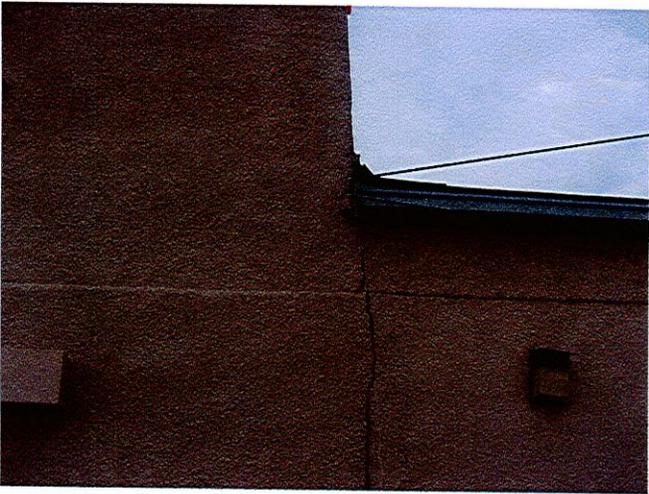
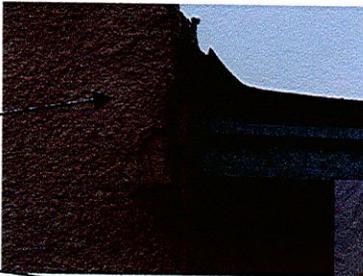
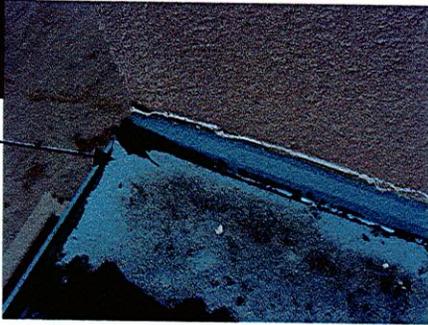
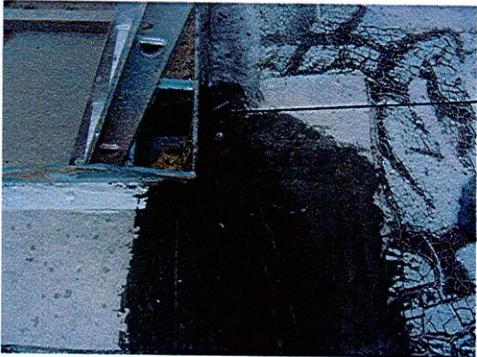
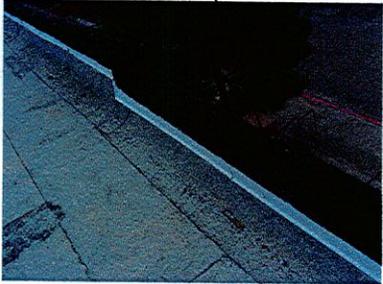
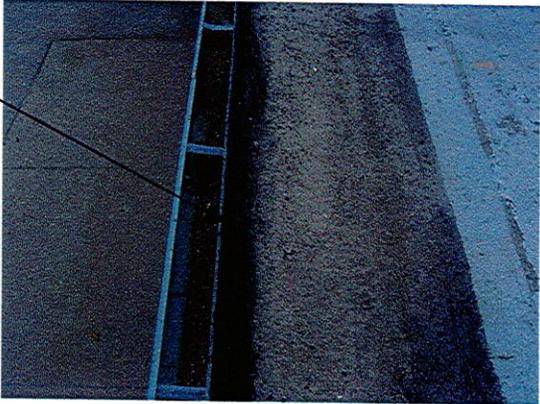
Roof Problems and Source of Water Intrusion

Parapet has sever cracks.

- The Building needs a new roof system, especially the parapet wall. The roof penetrations need to be re-sealed with roof cement. The building flashings need to be repaired.

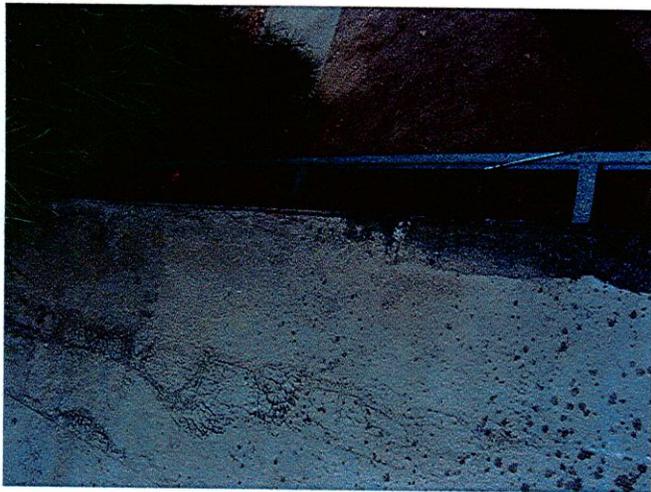
Clogged Roof Gutters, Water Intrusion Above Windows

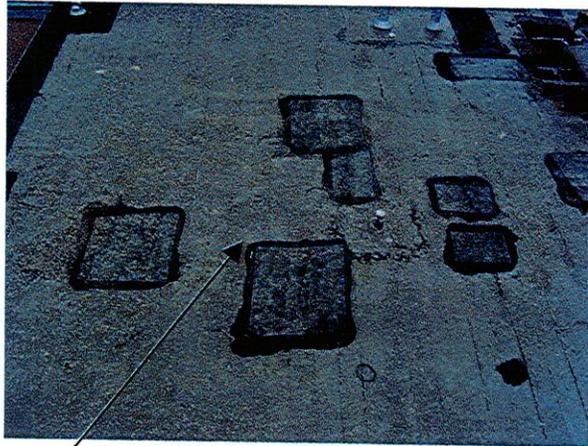
Roof Problems and Source of Water Intrusion

Extensive patch work throughout roof.

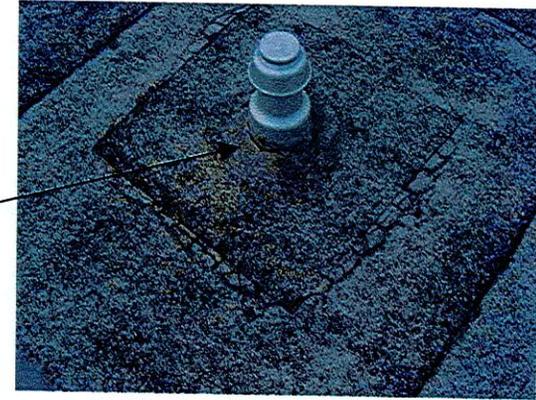
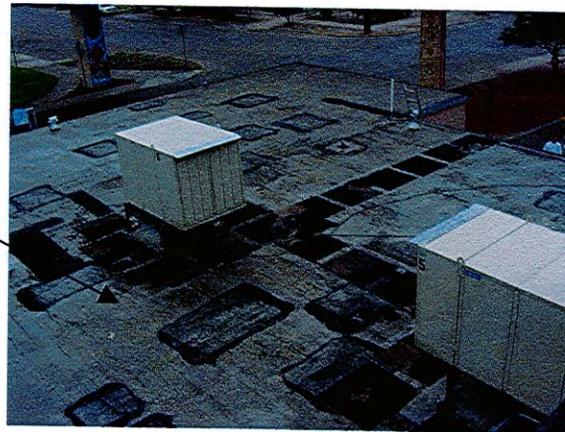
Roof flashing needs repair on various roof penetrations.

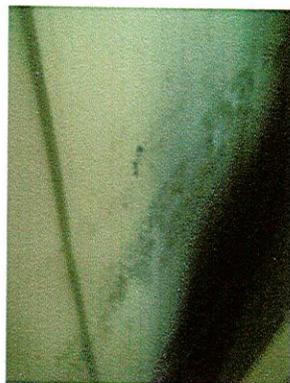
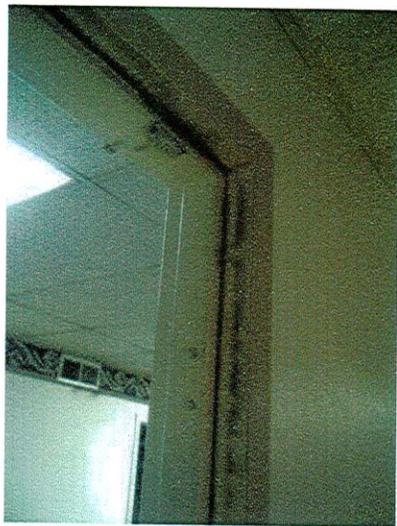
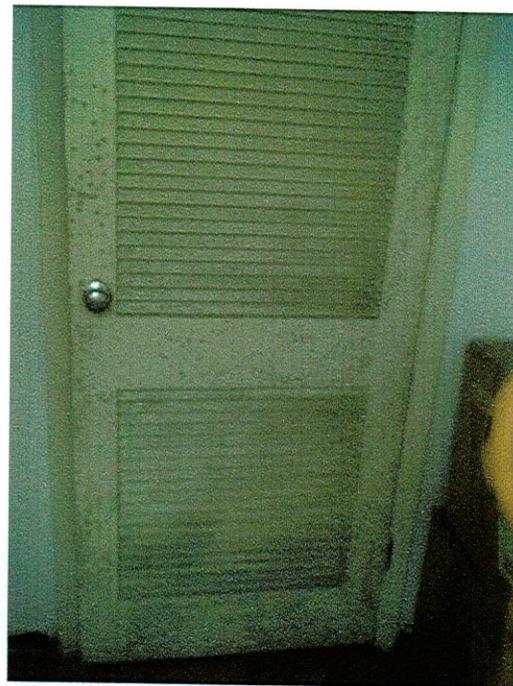
PHOTOGRAPHS TAKEN 10/03/06

On October 03, 2006, SCAI was allowed to assess the scope of work and present a formal proposal to the City of El Paso for this work. During this walk through SCAI observed the relative humidity to be around 72%. Moreover, SCAI found visible microbial growth on doors, door frames, and some walls (See photos for 10/03/06).
