# 3909 TULAROSA AVE

BUILDING AND STANDARDS BOARD AGENDA ITEM # 10 FOR  
WEDNESDAY, OCTOBER 27, 2010

SUBJECT: 3909 Tularosa Avenue, El Paso, Texas, 79903

# UNSAFE STRUCTURES REPORT

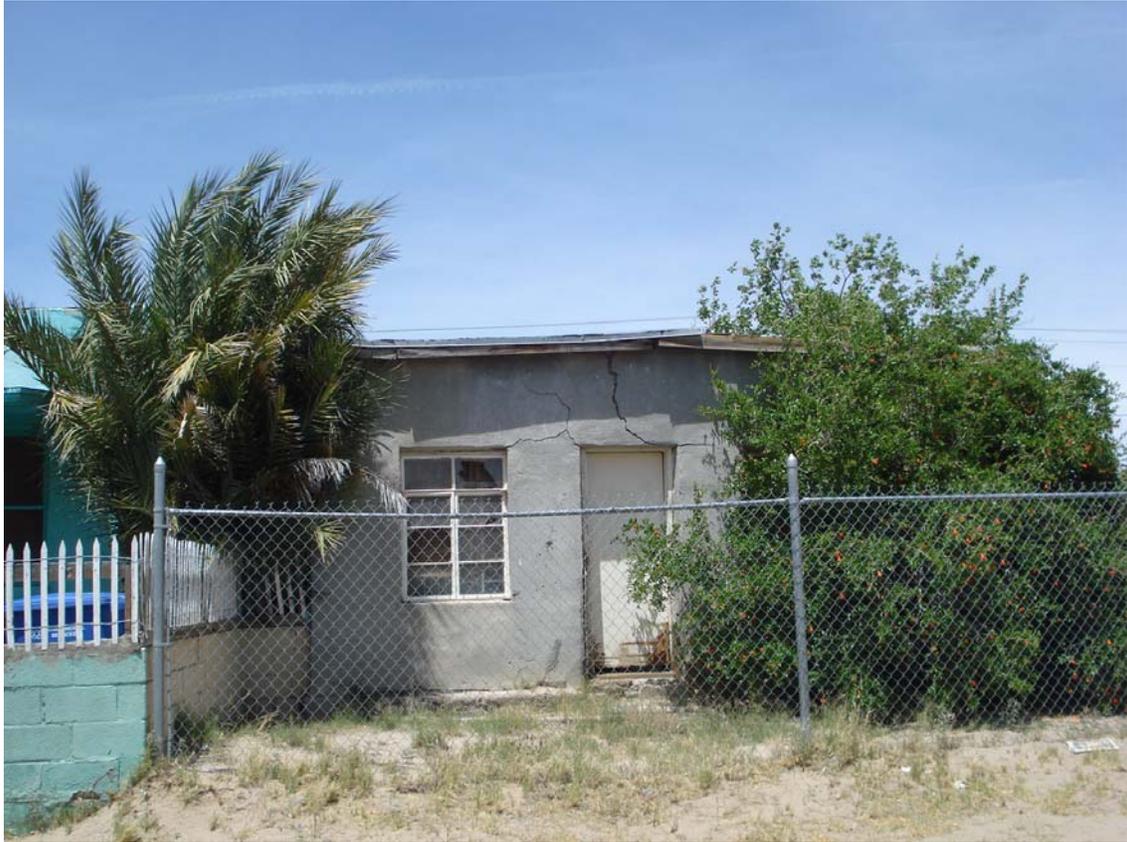
- 1) First investigated on April 28, 2010 and found to be fenced in and secure. After a follow up investigation on June 9, 2010. The structures were found open and abandoned and in a state of disrepair and accessible to unwanted entry by vagrants. The single family dwelling was built in 1912, of wood framed, Adobe walls covered with plaster coating. The exterior of the structures is showing signs of rapid deterioration due to lack of maintenance and exposure to the elements. The plaster coating has fallen in several areas exposing the underlying adobe to the elements. There are several structural cracks on the exterior walls that are ready to collapse.

**CONDITION:** Poor. Several structural deficiencies found major cracks on verge of collapse. A structural engineer should be hired to evaluate structural elements of the building and submit a report on the corrections required to make the building safe.

- 3) That the structure's certificate of occupancy be revoked; and
- 4) That the structures cannot be rehabilitated; and
- 5) That the structures be demolished within thirty (30) days; and
